## **TAMU Project**

**Energy Consumption Data Quality Assurance/Quality  
Control Assessment Report for the  
Month of August 2016**

**Utility & Energy Services  
Division of Administration  
Texas A&M University**

**September 2016**

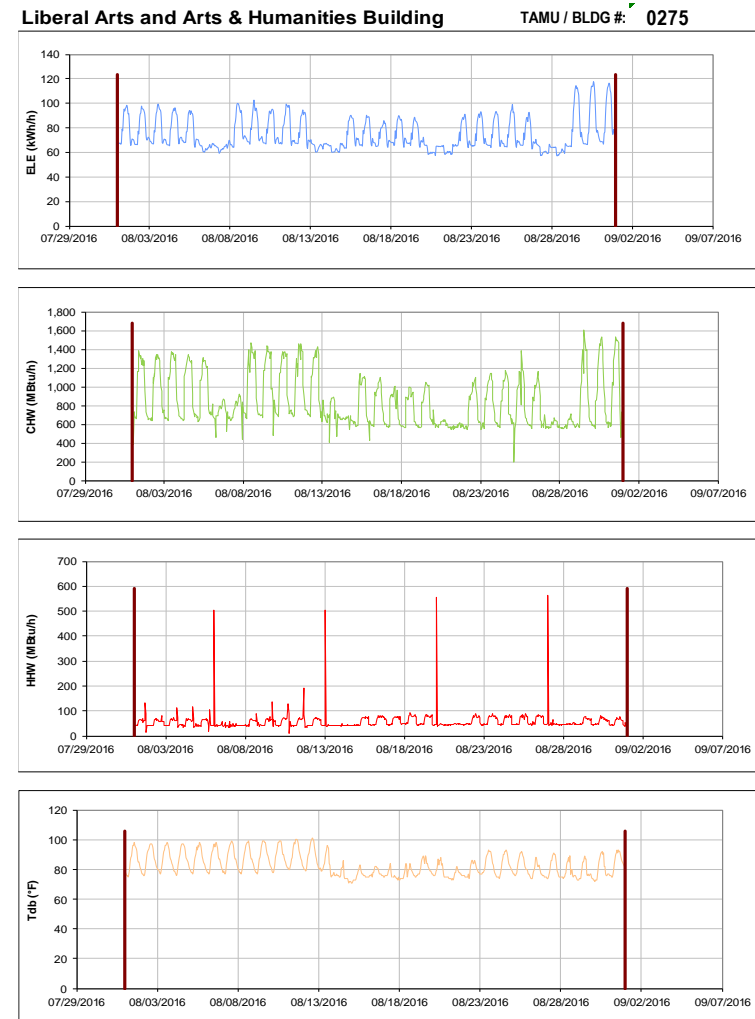
Figure III-2 Hourly Whole Building Electricity, Chilled Water, and Hot Water Consumption for Liberal Arts and Arts & Humanities Building during the Month of August 2016 and the Corresponding Hourly Outdoor Dry Bulb Temperature for College Station, TX

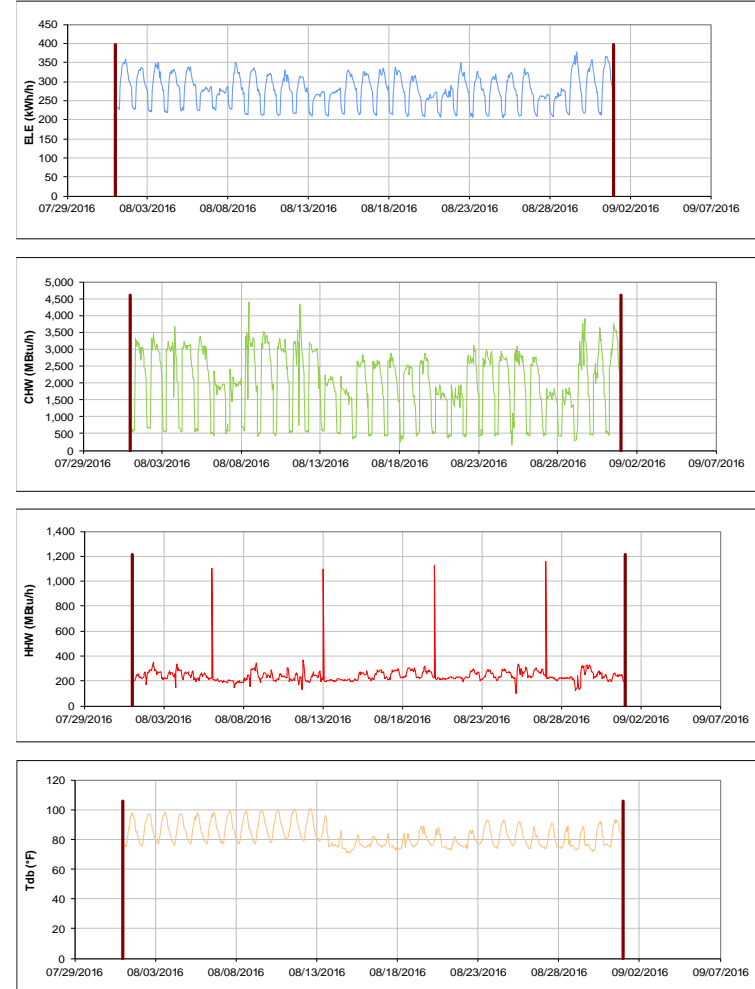
Mitchell Inst. for Fundamental Phys & Astronomy TAMU / BLDG #: 296-0297

Figure III-8 Hourly Whole Building Electricity, Chilled Water, and Hot Water Consumption for Mitchell Inst. for Fundamental Phys & Astronomy during the Month of August 2016 and the Corresponding Hourly Outdoor Dry Bulb Temperature for College Station, TX

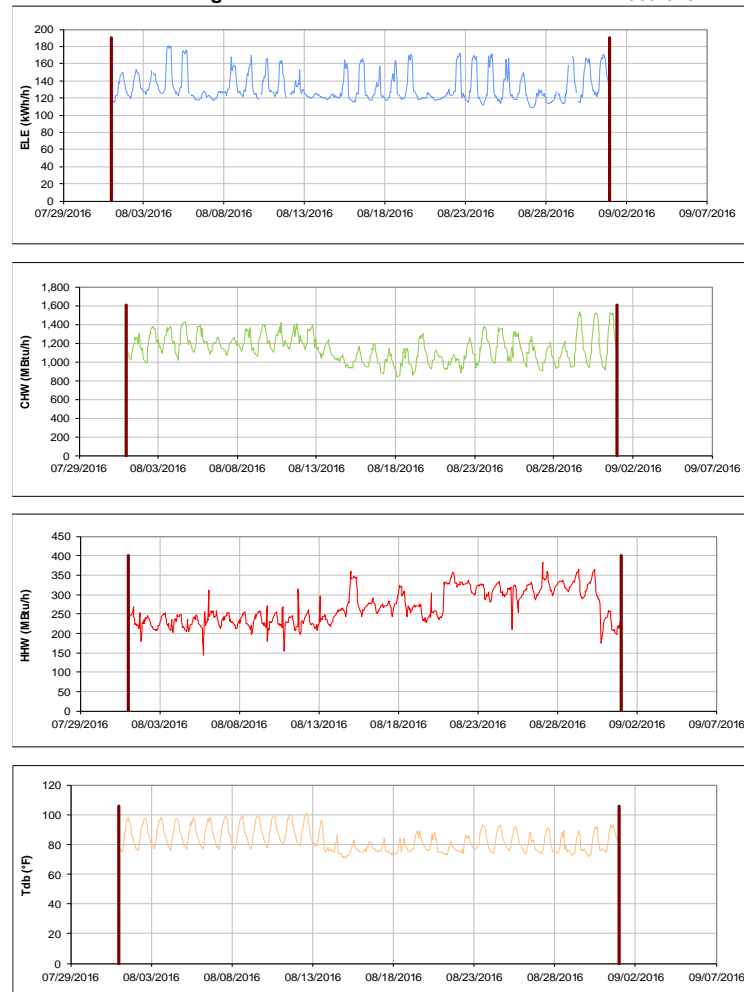
**Architecture Building B&C** TAMU / BLDG #: 1359-0432

Figure III-12 Hourly Whole Building Electricity, Chilled Water, and Hot Water Consumption for Architecture Building B&C during the Month of August 2016 and the Corresponding Hourly Outdoor Dry Bulb Temperature for College Station, TX

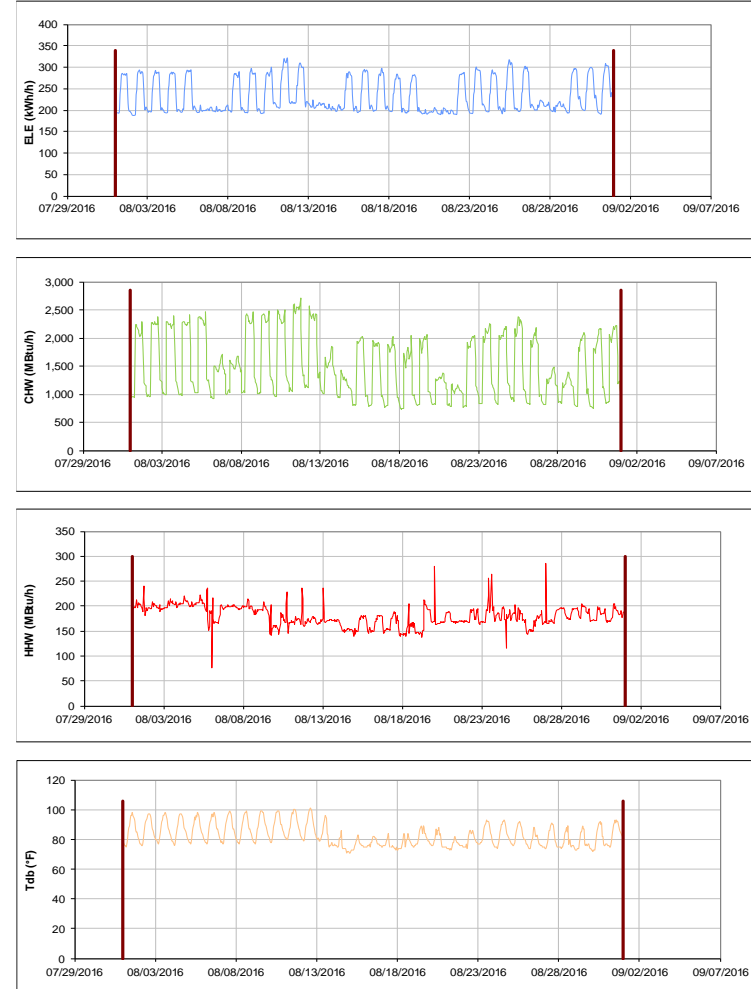
TAMU / BLDG #: 0383

Figure III-18 Hourly Whole Building Electricity, Chilled Water, and Hot Water Consumption for Koldus Building during the Month of August 2016 and the Corresponding Hourly Outdoor Dry Bulb Temperature for College Station, TX

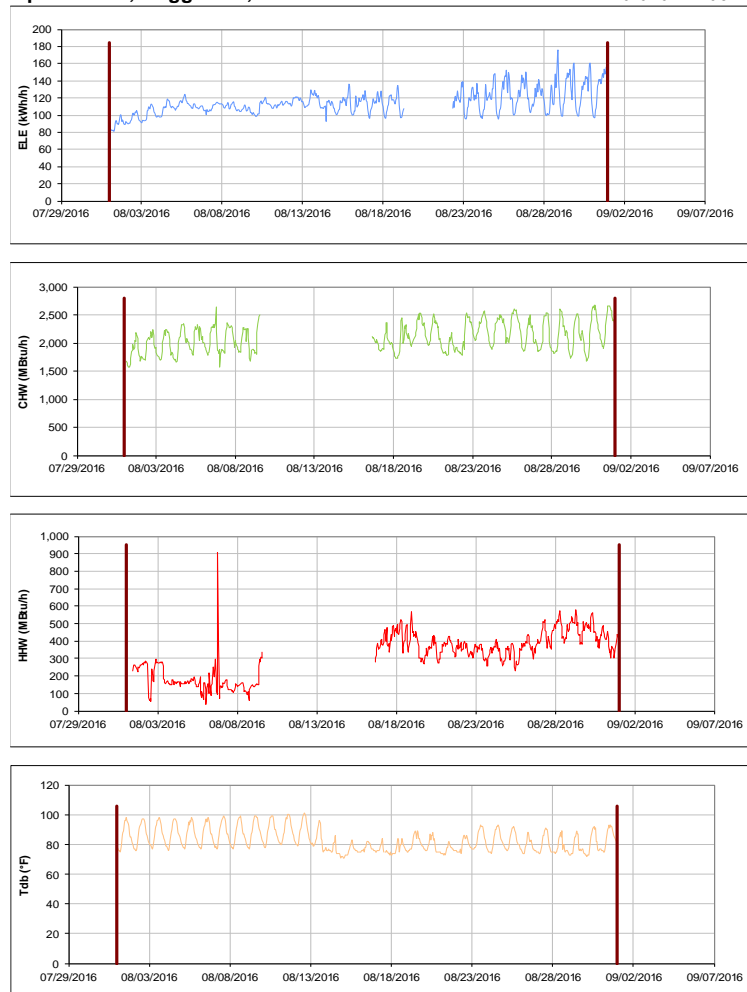
Spence Hall, Briggs Hall, and Ash II LLC TAMU / BLDG #: 0-0402-1405

Figure III-25 Hourly Whole Building Electricity, Chilled Water, and Hot Water Consumption for Spence Hall, Briggs Hall, and Ash II LLC during the Month of August 2016 and the Corresponding Hourly Outdoor Dry Bulb Temperature for College Station, TX

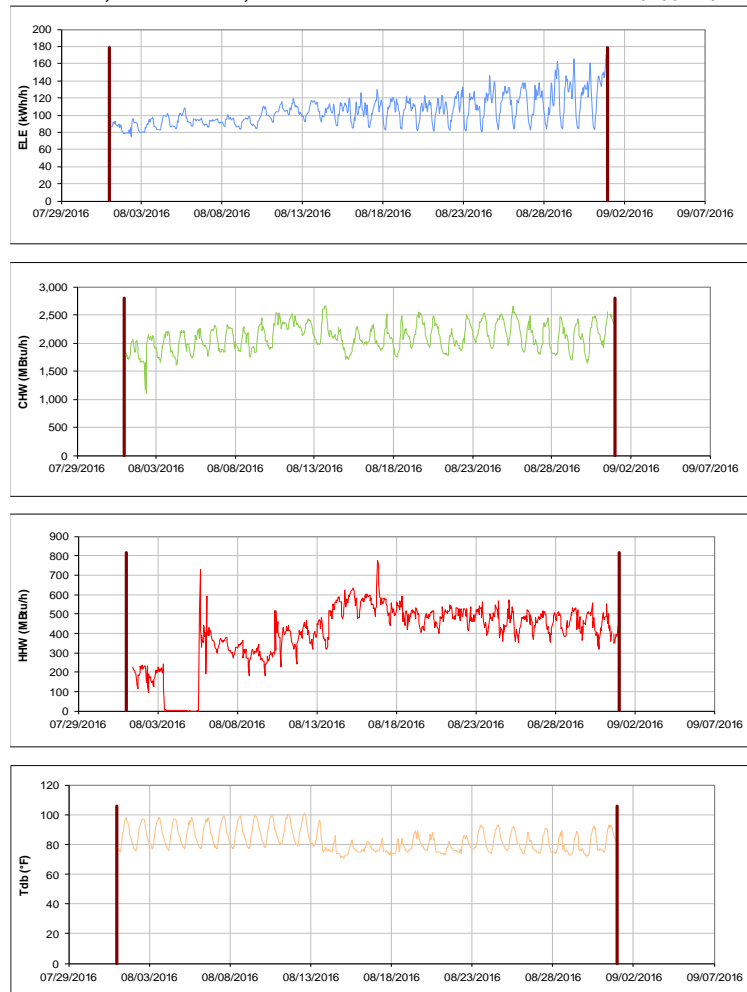
**Kiest Hall, Fountain Hall, and Plank LLC** TAMU / BLDG #: 1-0403-1404

Figure III-29 Hourly Whole Building Electricity, Chilled Water, and Hot Water Consumption for Kiest Hall, Fountain Hall, and Plank LLC during the Month of August 2016 and the Corresponding Hourly Outdoor Dry Bulb Temperature for College Station, TX

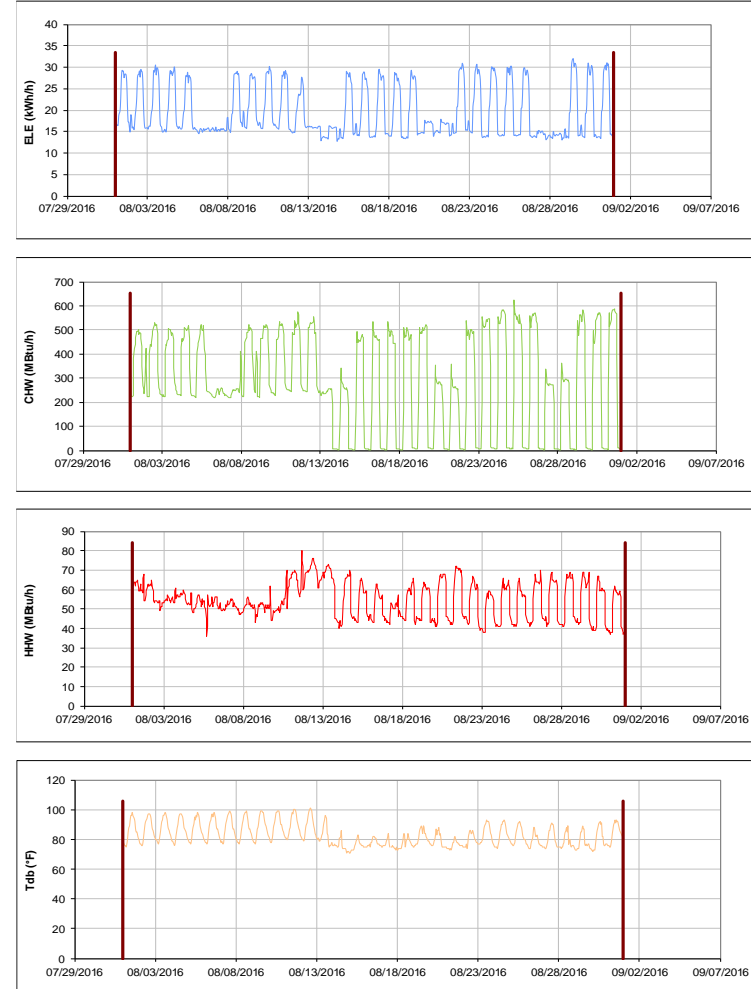
TAMU / BLDG #: 0424

Figure III-46 Hourly Whole Building Electricity, Chilled Water, and Hot Water Consumption for Hotard Hall during the Month of August 2016 and the Corresponding Hourly Outdoor Dry Bulb Temperature for College Station, TX

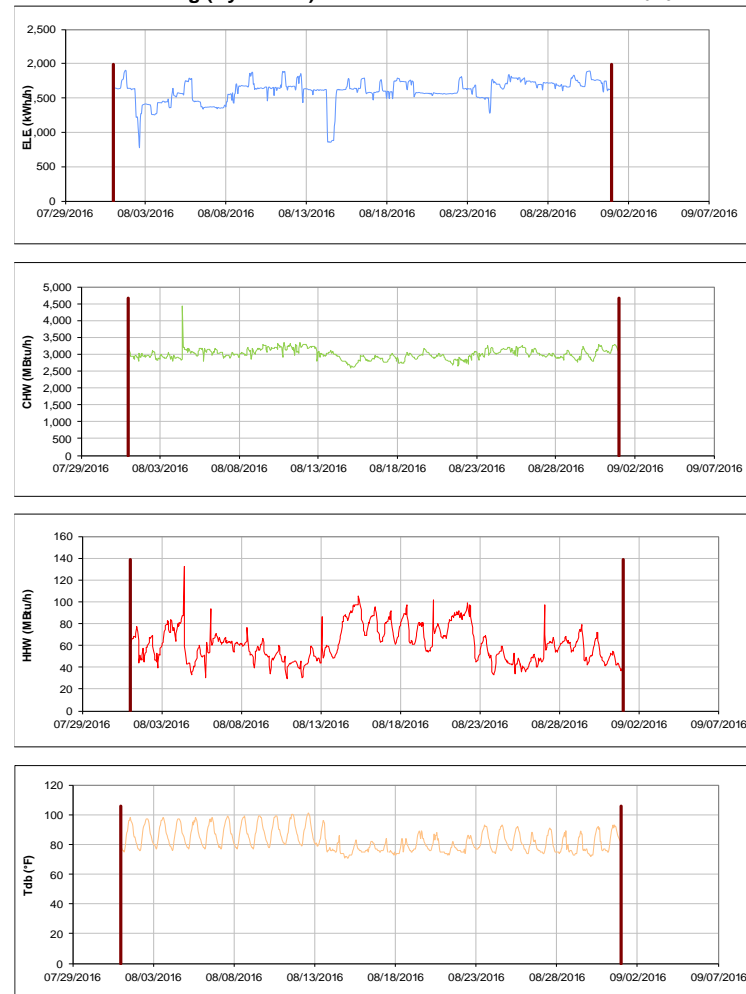
TAMU / BLDG #: 0434

Figure III-56 Hourly Whole Building Electricity, Chilled Water, and Hot Water Consumption for Luedecke Building (Cyclotron) during the Month of August 2016 and the Corresponding Hourly Outdoor Dry Bulb Temperature for College Station, TX

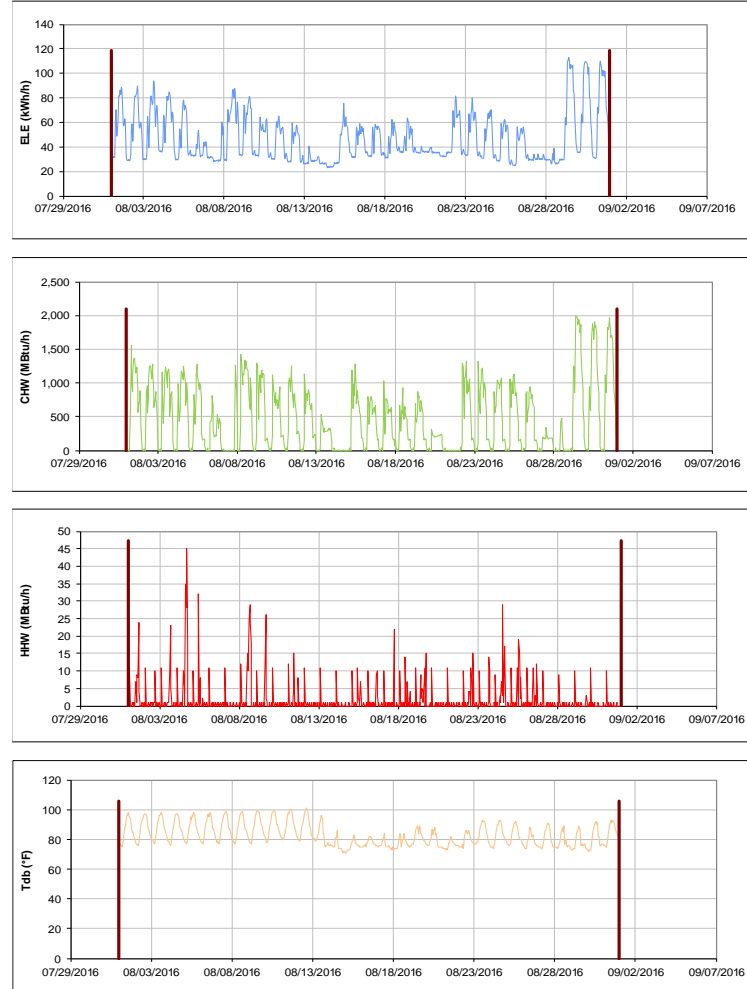
**Harrington Education Center Classroom Building** TAMU / BLDG #: 0438

Figure III-61 Hourly Whole Building Electricity, Chilled Water, and Hot Water Consumption for Harrington Education Center Classroom Building during the Month of August 2016 and the Corresponding Hourly Outdoor Dry Bulb Temperature for College Station, TX

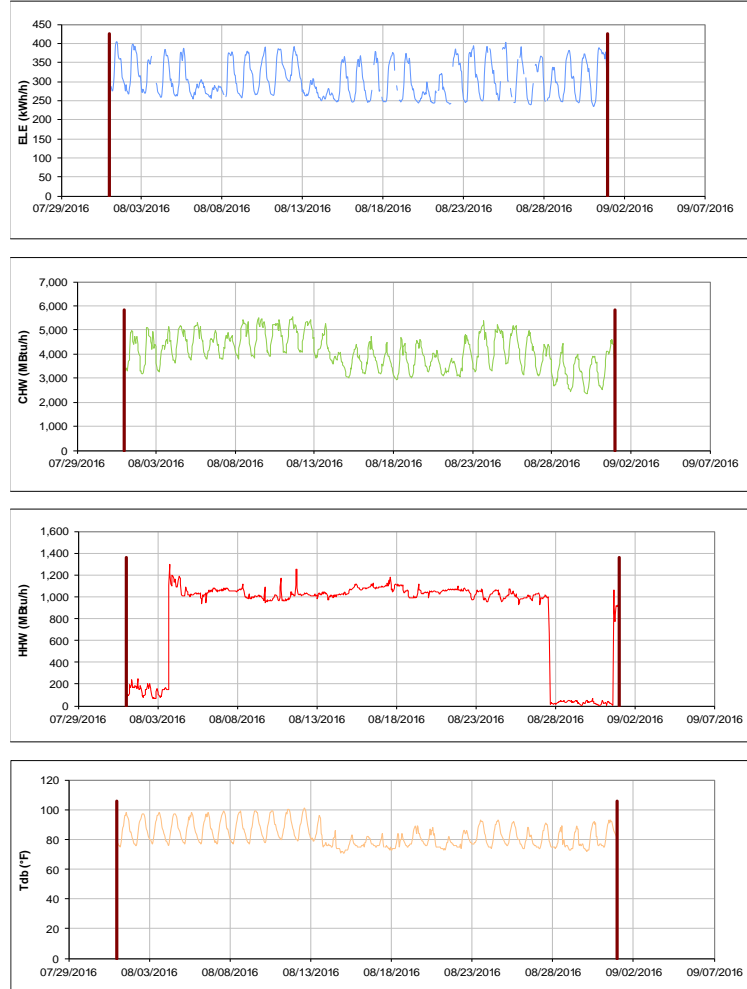
TAMU / BLDG #: 0446

Figure III-67 Hourly Whole Building Electricity, Chilled Water, and Hot Water Consumption for Rudder Tower and Theatre Complex during the Month of August 2016 and the Corresponding Hourly Outdoor Dry Bulb Temperature for College Station, TX

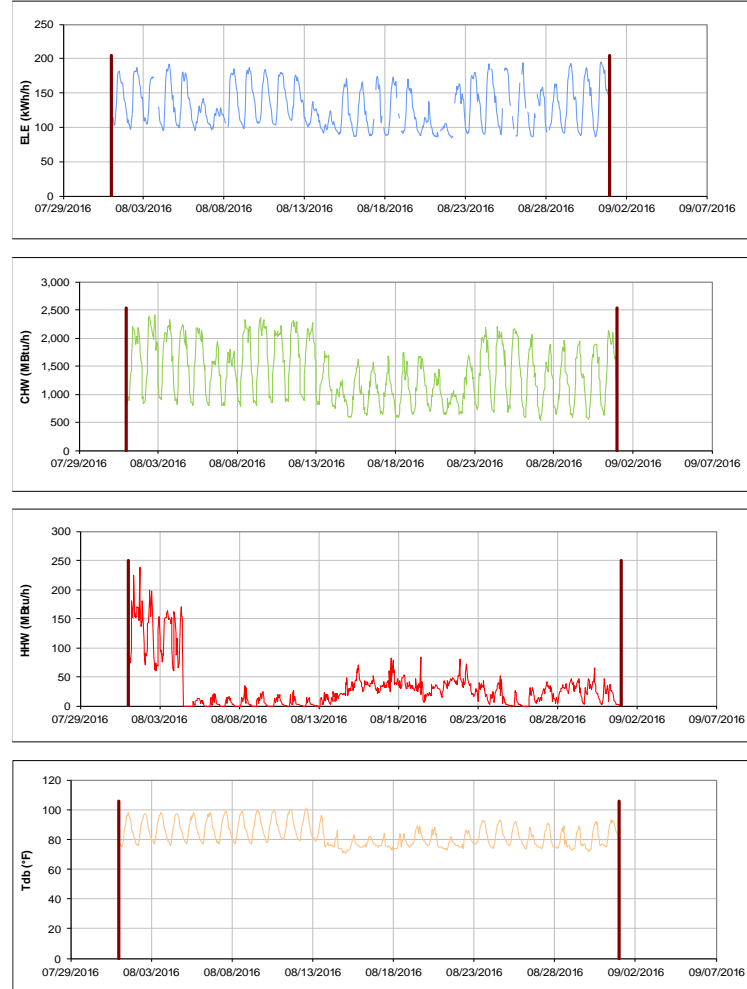
TAMU / BLDG #: 0446-B

Figure III-69 Hourly Whole Building Electricity, Chilled Water, and Hot Water Consumption for Rudder Tower during the Month of August 2016 and the Corresponding Hourly Outdoor Dry Bulb Temperature for College Station, TX

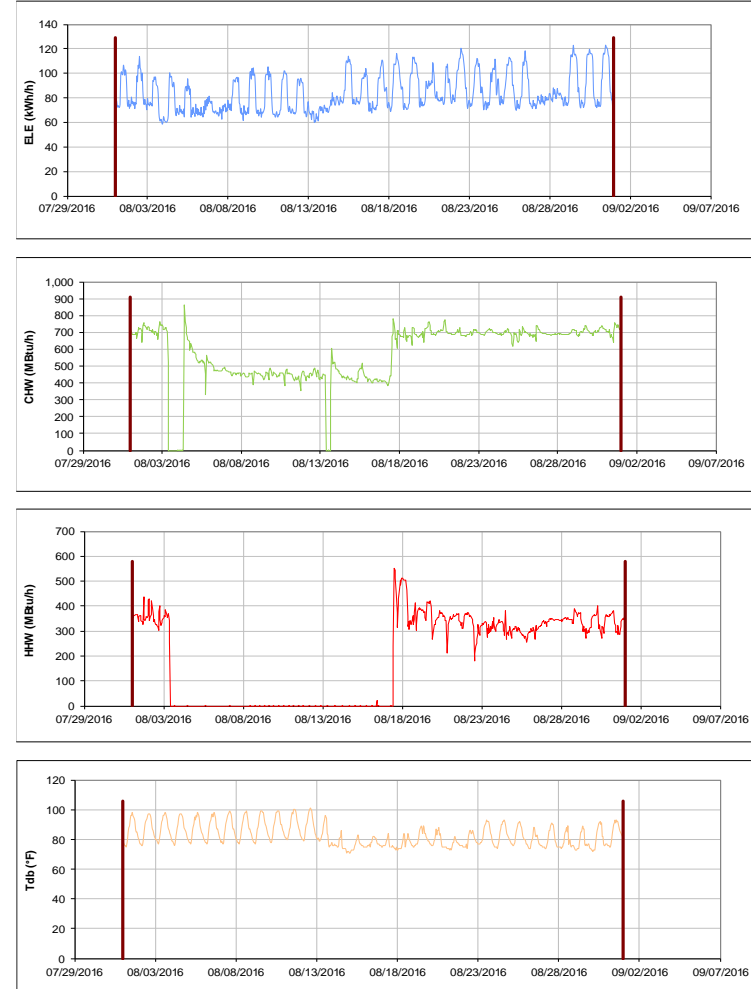
TAMU / BLDG #: 0448

Figure III-70 Hourly Whole Building Electricity, Chilled Water, and Hot Water Consumption for Adams Band Hall during the Month of August 2016 and the Corresponding Hourly Outdoor Dry Bulb Temperature for College Station, TX

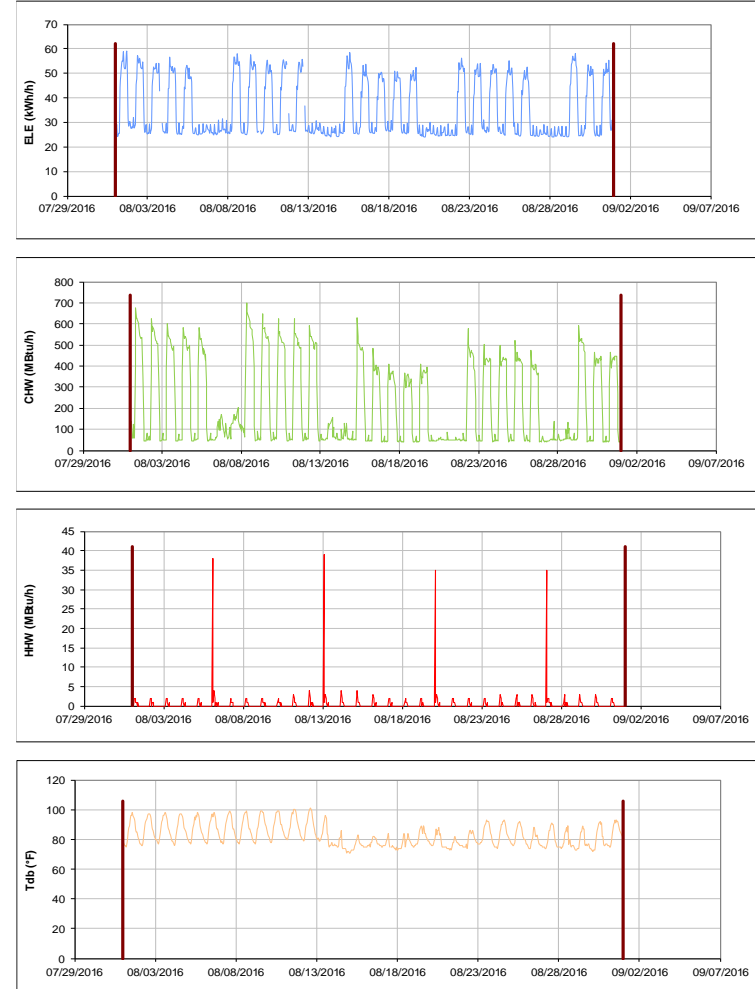
TAMU / BLDG #: 0461

Figure III-76 Hourly Whole Building Electricity, Chilled Water, and Hot Water Consumption for Coke Building during the Month of August 2016 and the Corresponding Hourly Outdoor Dry Bulb Temperature for College Station, TX

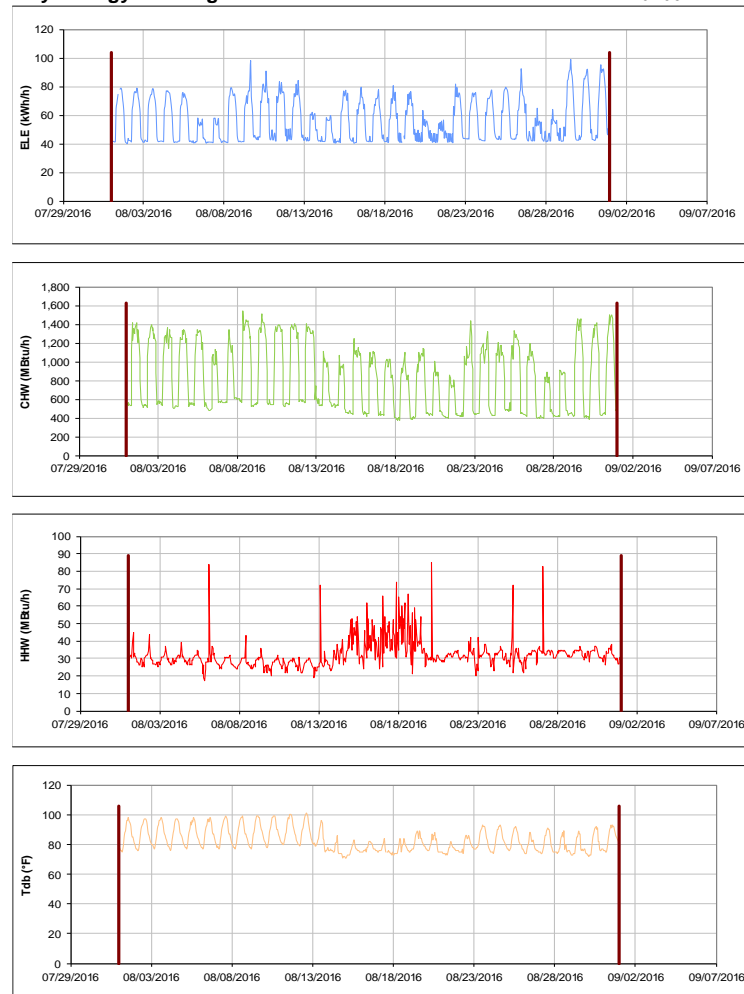
TAMU / BLDG #: 0463

Figure III-78 Hourly Whole Building Electricity, Chilled Water, and Hot Water Consumption for Psychology Building during the Month of August 2016 and the Corresponding Hourly Outdoor Dry Bulb Temperature for College Station, TX

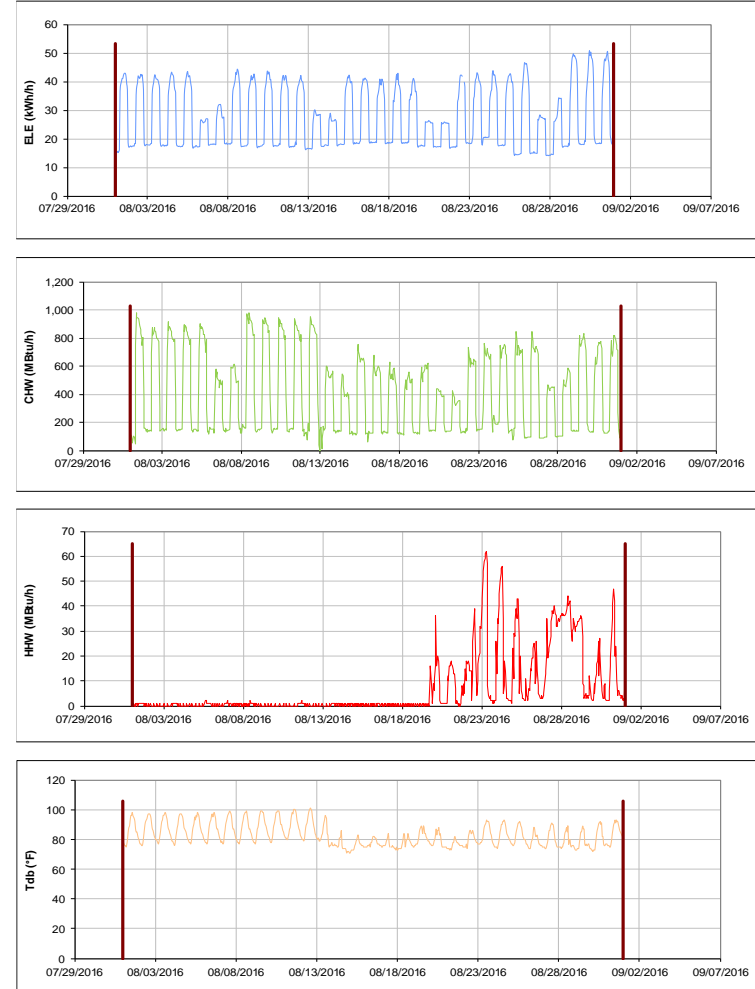
TAMU / BLDG #: 0470

Figure III-84 Hourly Whole Building Electricity, Chilled Water, and Hot Water Consumption for Glasscock History Bldg during the Month of August 2016 and the Corresponding Hourly Outdoor Dry Bulb Temperature for College Station, TX

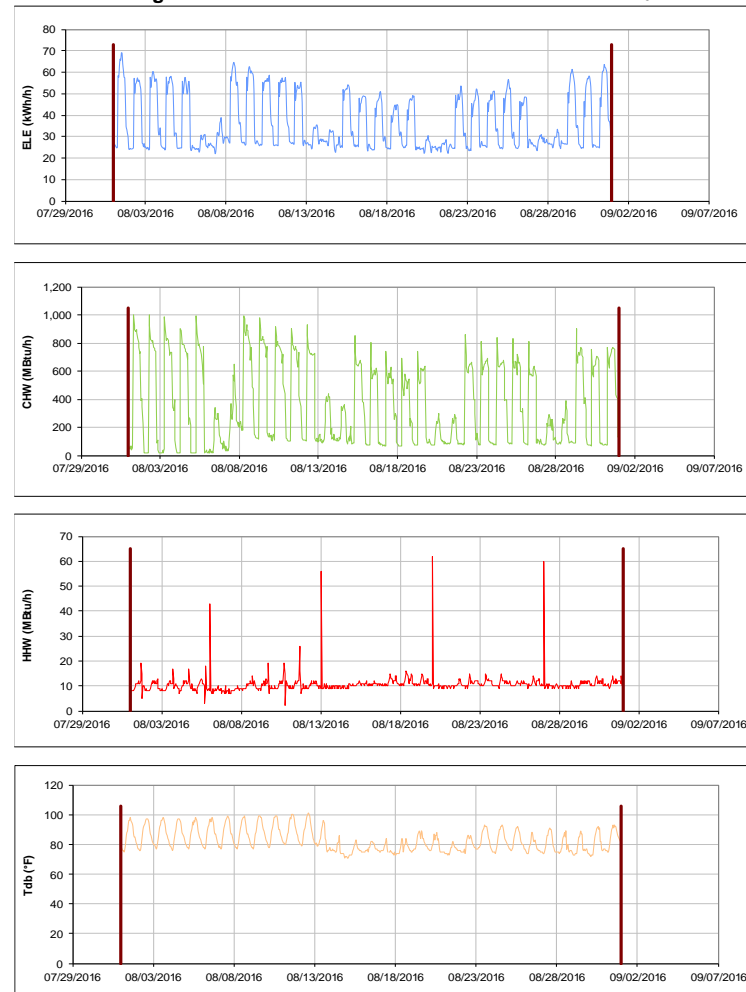
TAMU / BLDG #: 0474

Figure III-88 Hourly Whole Building Electricity, Chilled Water, and Hot Water Consumption for YMCA Building during the Month of August 2016 and the Corresponding Hourly Outdoor Dry Bulb Temperature for College Station, TX

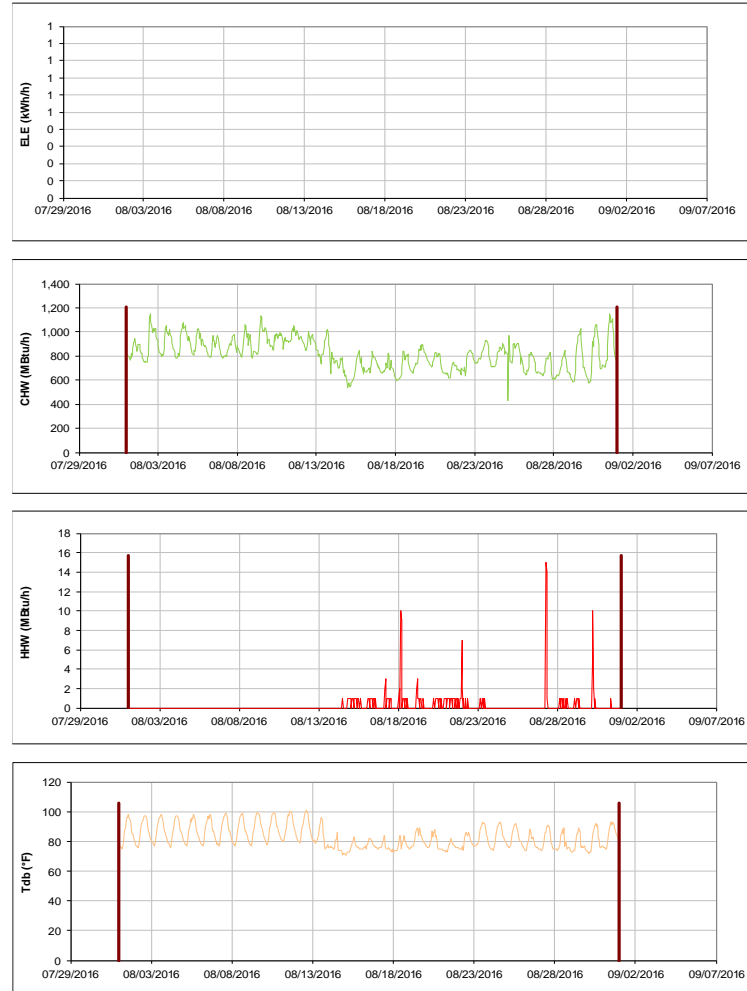
TAMU / BLDG #: 0476

Figure III-89 Hourly Whole Building Electricity, Chilled Water, and Hot Water Consumption for Francis Hall during the Month of August 2016 and the Corresponding Hourly Outdoor Dry Bulb Temperature for College Station, TX

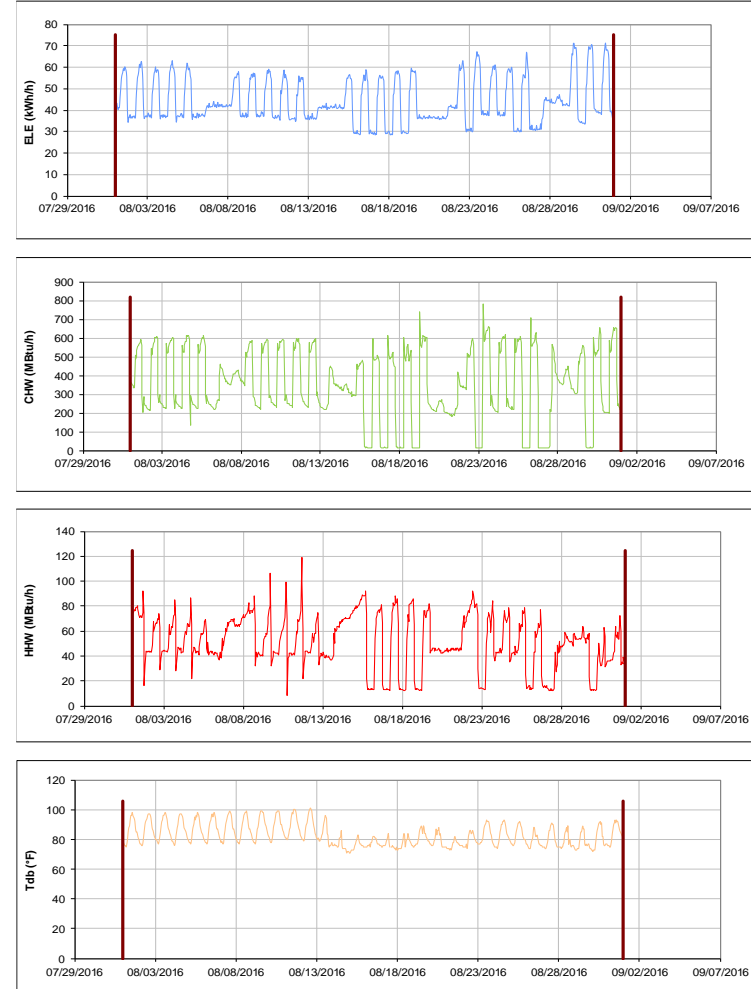
TAMU / BLDG #: 0480

Figure III-92 Hourly Whole Building Electricity, Chilled Water, and Hot Water Consumption for Bolton Hall during the Month of August 2016 and the Corresponding Hourly Outdoor Dry Bulb Temperature for College Station, TX

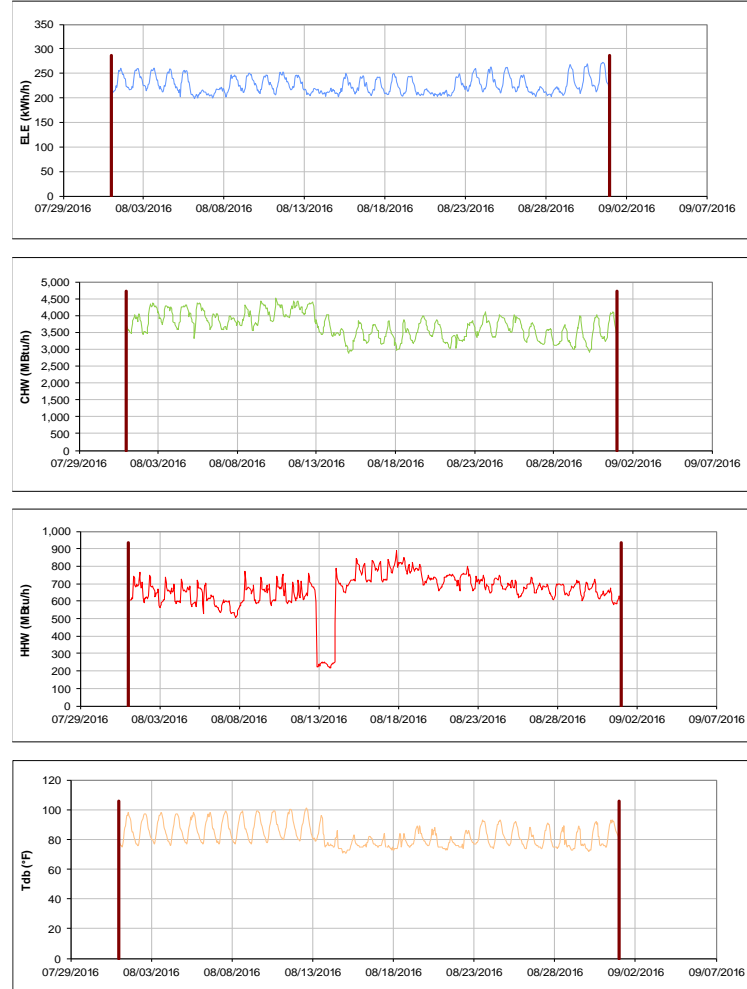
TAMU / BLDG #: 0490

Figure III-97 Hourly Whole Building Electricity, Chilled Water, and Hot Water Consumption for Halbouty Geosciences Building during the Month of August 2016 and the Corresponding Hourly Outdoor Dry Bulb Temperature for College Station, TX

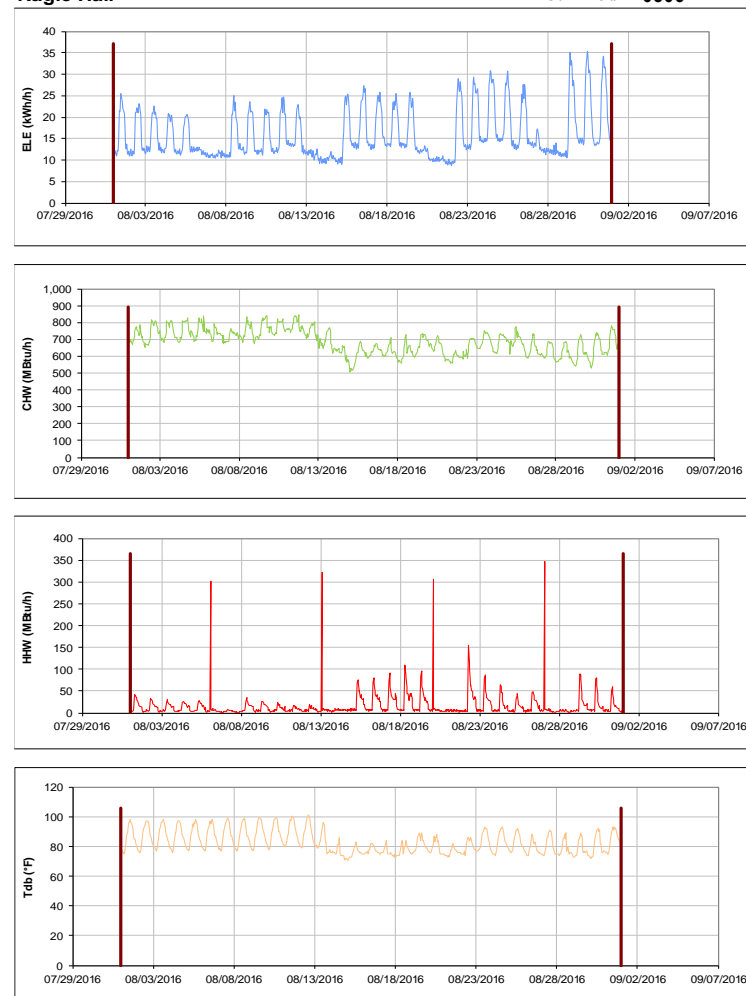
TAMU / BLDG #: 0506

Figure III-102 Hourly Whole Building Electricity, Chilled Water, and Hot Water Consumption for Nagle Hall during the Month of August 2016 and the Corresponding Hourly Outdoor Dry Bulb Temperature for College Station, TX

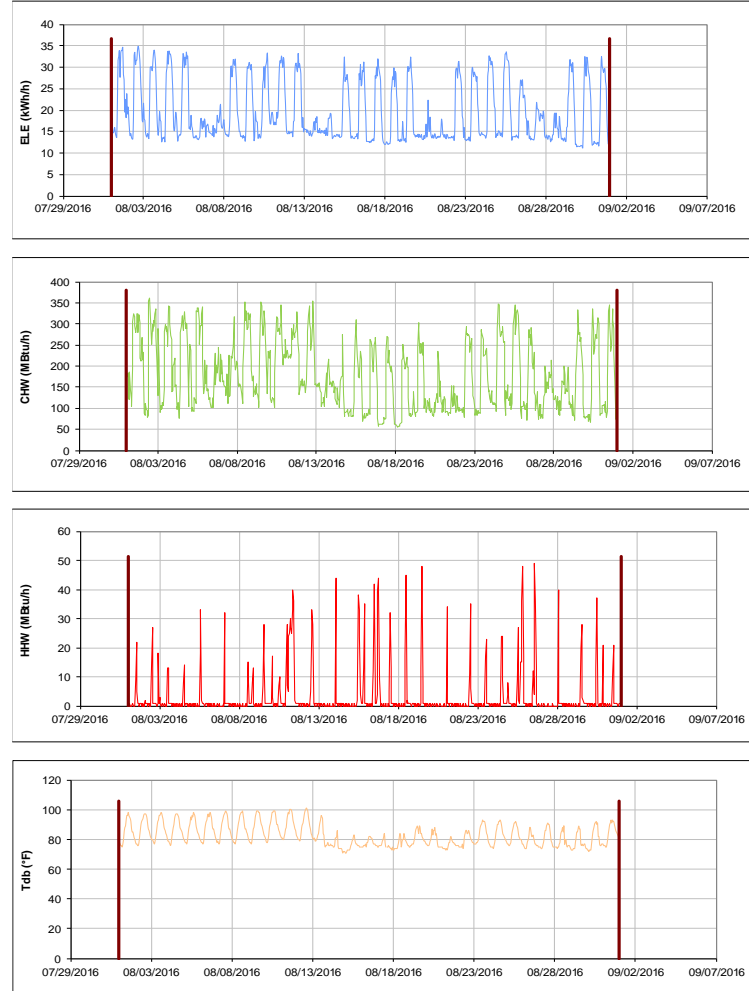
**Munnerlyn Astronomy & Space Sciences Engineering** TAMU / BLDG #: 0514

Figure III-109 Hourly Whole Building Electricity, Chilled Water, and Hot Water Consumption for Munnerlyn Astronomy & Space Sciences Engineering during the Month of August 2016 and the Corresponding Hourly Outdoor Dry Bulb Temperature for College Station, TX

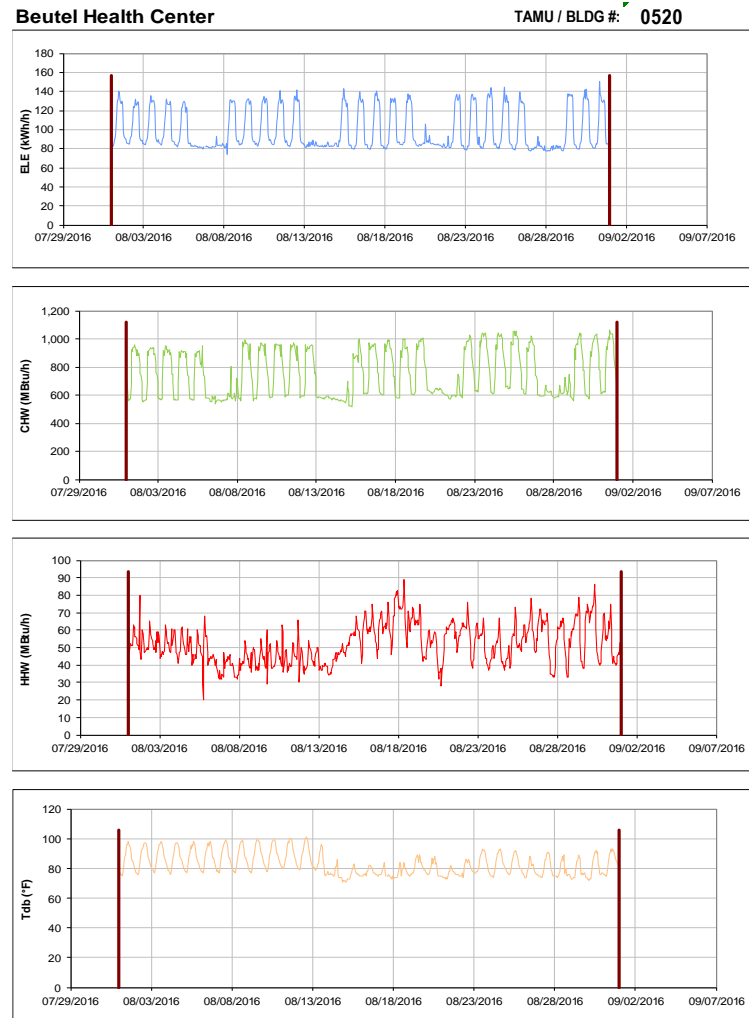
Figure III-111 Hourly Whole Building Electricity, Chilled Water, and Hot Water Consumption for Beutel Health Center during the Month of August 2016 and the Corresponding Hourly Outdoor Dry Bulb Temperature for College Station, TX

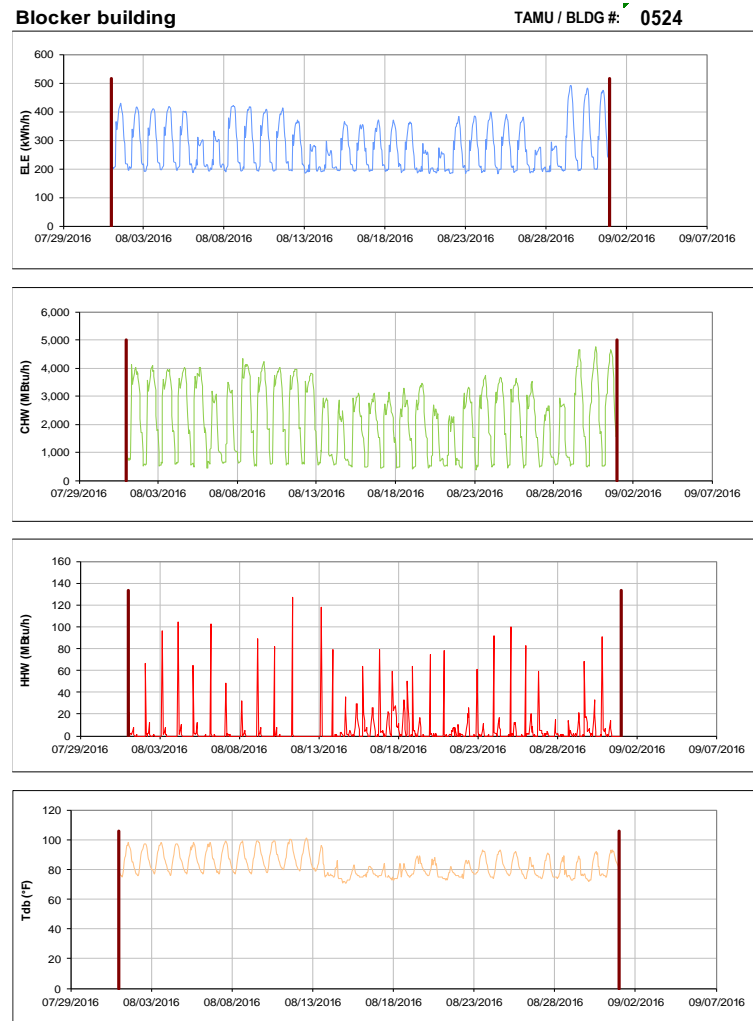
Figure III-113 Hourly Whole Building Electricity, Chilled Water, and Hot Water Consumption for Blocker building during the Month of August 2016 and the Corresponding Hourly Outdoor Dry Bulb Temperature for College Station, TX

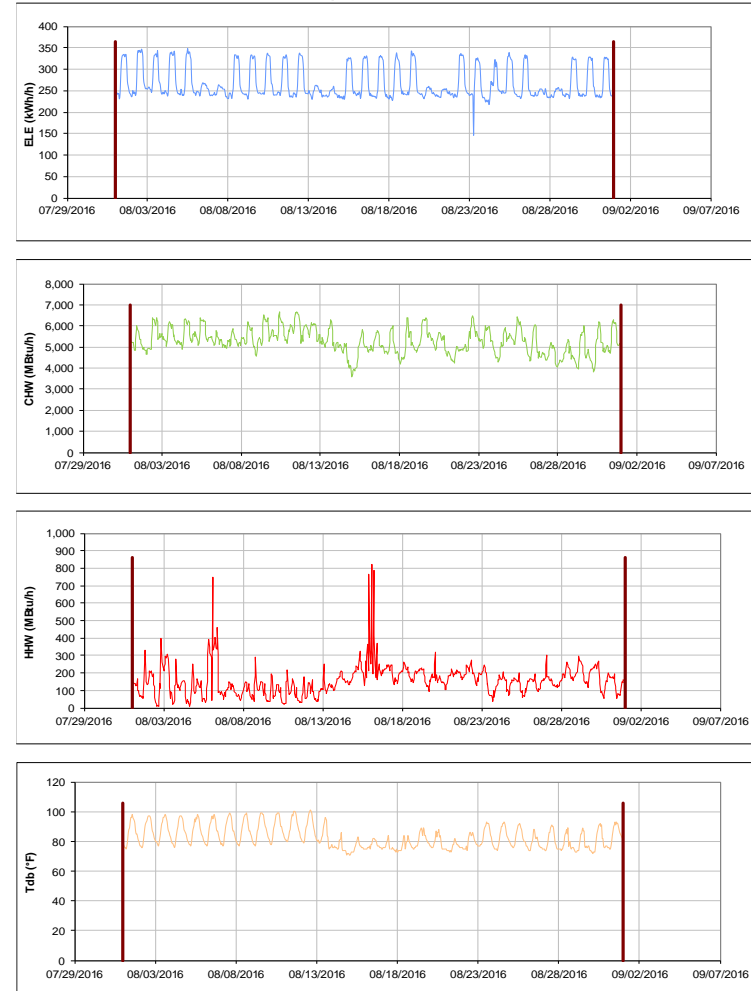
TAMU / BLDG #: 0972

Figure III-124 Hourly Whole Building Electricity, Chilled Water, and Hot Water Consumption for Laboratory Animal Care Building during the Month of August 2016 and the Corresponding Hourly Outdoor Dry Bulb Temperature for College Station, TX

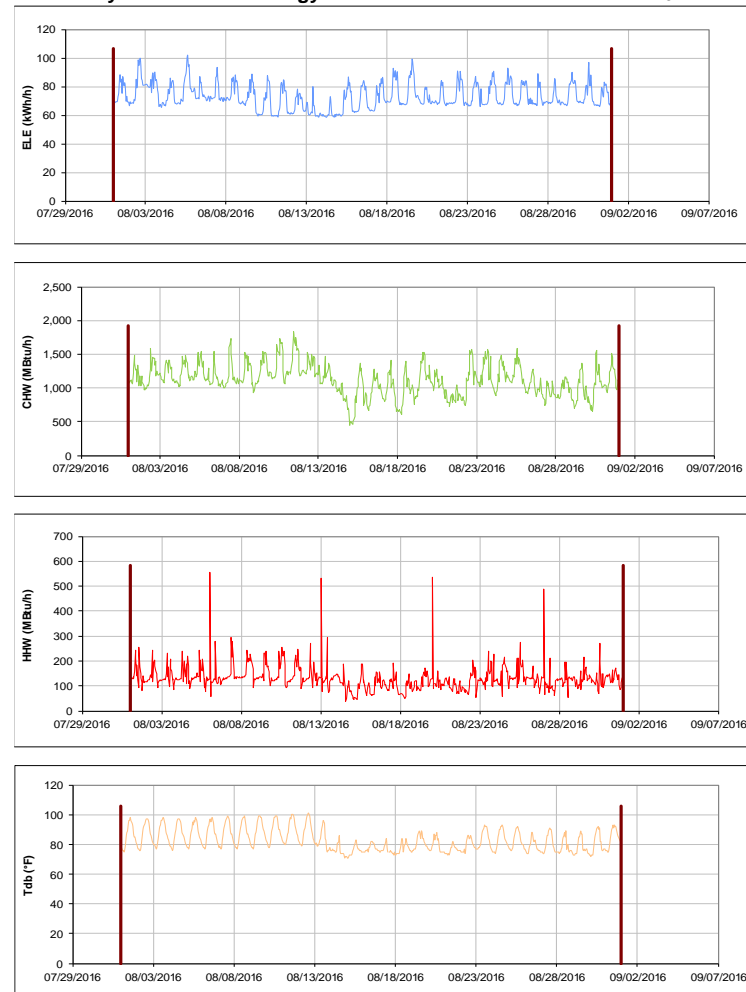
TAMU / BLDG #: 1184

Figure III-132 Hourly Whole Building Electricity, Chilled Water, and Hot Water Consumption for Veterinary Anatomic Pathology during the Month of August 2016 and the Corresponding Hourly Outdoor Dry Bulb Temperature for College Station, TX

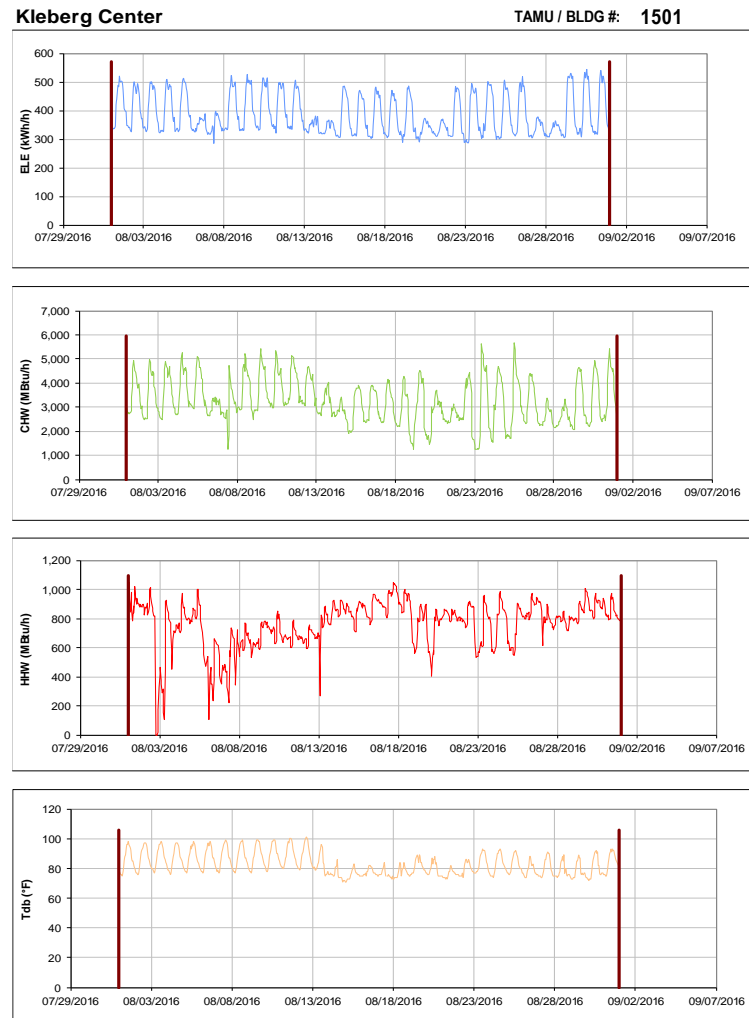
Figure III-147 Hourly Whole Building Electricity, Chilled Water, and Hot Water Consumption for Kleberg Center during the Month of August 2016 and the Corresponding Hourly Outdoor Dry Bulb Temperature for College Station, TX

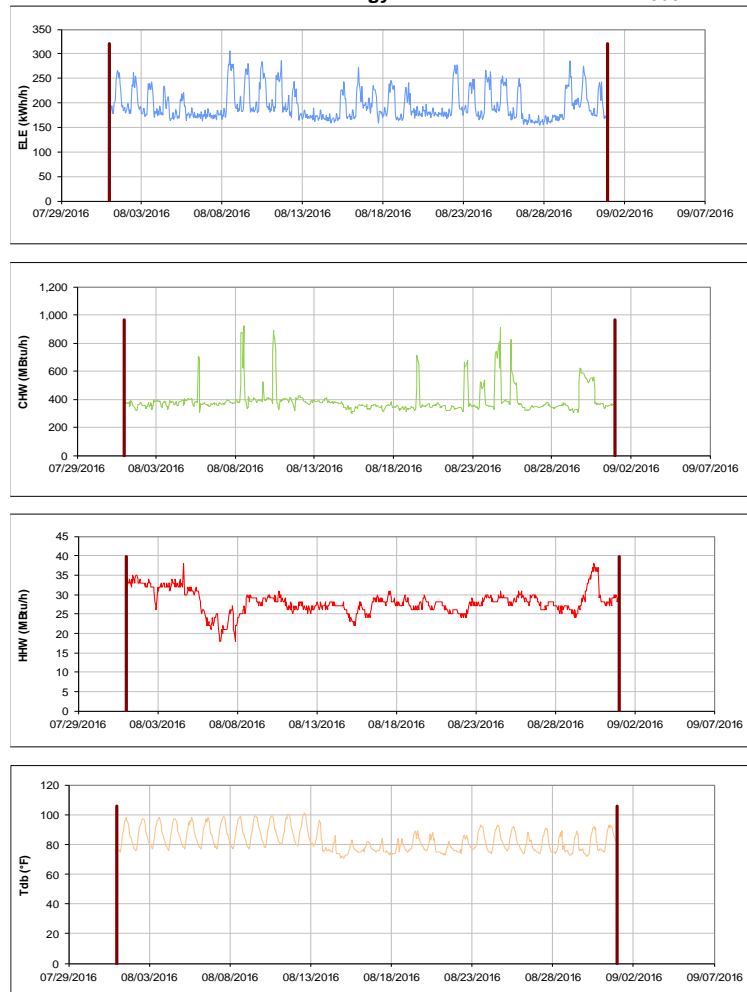
**Rosenthal Meat Science & Technology Center** TAMU / BLDG #: 1505

Figure III-151 Hourly Whole Building Electricity, Chilled Water, and Hot Water Consumption for Rosenthal Meat Science & Technology Center during the Month of August 2016 and the Corresponding Hourly Outdoor Dry Bulb Temperature for College Station, TX

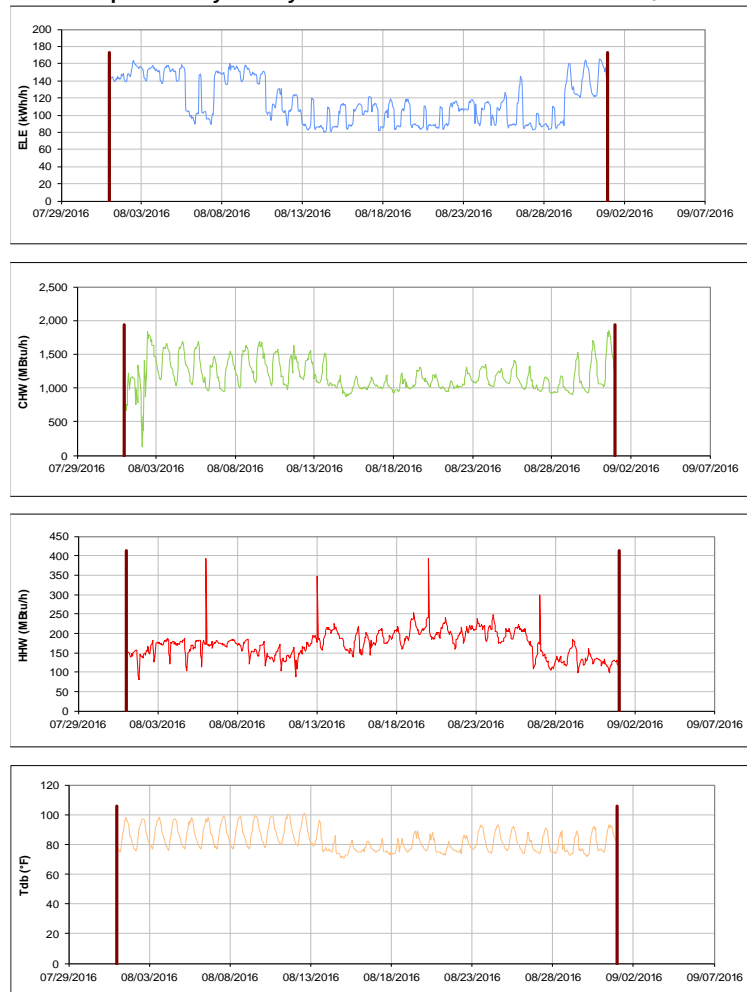
TAMU / BLDG #: 1511

Figure III-157 Hourly Whole Building Electricity, Chilled Water, and Hot Water Consumption for West Campus Library Facility during the Month of August 2016 and the Corresponding Hourly Outdoor Dry Bulb Temperature for College Station, TX
